# QB33AR / QB44AR

3/4" - 1" two piece anti-rotation quick coupler valves

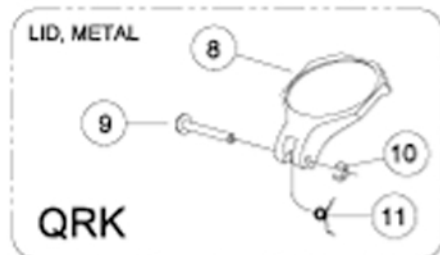
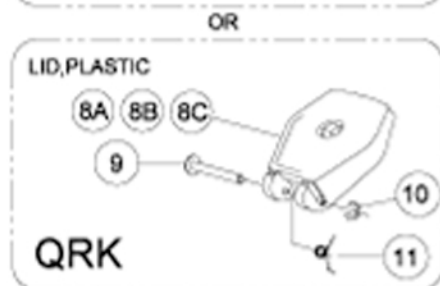
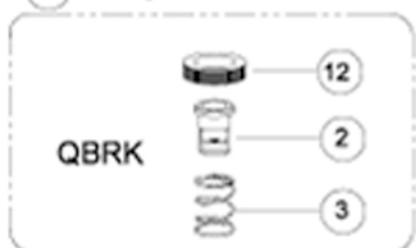
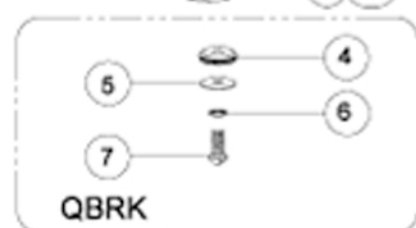
- "QBRK" Repair Kit:**  
 2 Plunger  
 3 Spring  
 4 Rubber Seat  
 5 Washer s/s  
 6 Washer fiber  
 7 Screw  
 12 Seal  
 16 Upper Body Bolt

- "QRK" Lid Repair Kit:**  
 8 Brass Cover  
 8A Yellow Tuff-Top  
 8B Locking Yellow Tuff-Top  
 8C Purple Non-Potable Locking Tuff-Top  
 9 Pin  
 10 E-Clip  
 11 Lid Spring

- Items sold separately:**  
 13 Body  
 13A Body (BSPT)  
 15,16 Upper Body w/ Bolt

- Water leaks around valve:
  - Check QCV key part number to make sure it is compatible with the QCV.
  - Check U-Cup seal (# 12) for wear or damage. Replace as necessary.
  - Check key for wear, pits, cracks, etc.
  - Check inside valve for obstructions: rocks, twigs, leaves, etc.
- Valve leaks constantly:
  - Check valve for obstructions.
  - Check rubber seat (# 4) for wear or damage. Replace as necessary.
  - Check installation. Make sure valve is not cross-threaded onto riser and all other connections are water-tight. Use teflon tape on all threads (# 7). Never use teflon paste near valves.
